Collapse of HDC Apartment due to "Unauthorized Structural Change"

Overall unreliable management of working scene with negligent quality control and supervision of concrete assessed to be leading cause of collapse

The Accident Investigation Committee (Chairman: Professor Kim, Gyu-Yong, Chungnam National University, hereinafter referred to as "AIC") for the HDC Apartment Collapse announced the investigation result of the collapse* that occurred at the Gwangju apartment construction site on January 11th.

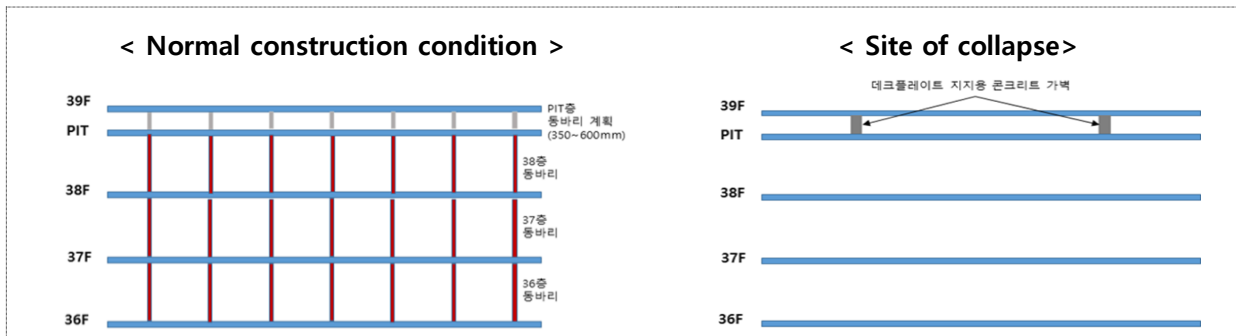
① The construction method and support method of the 39th floor differed from the original design document, and with a concrete fake wall installed at the bottom of the PIT layer, the applied load on the bottom slab of the PIT layer reached a heavier state than the planned design** with the load concentrated toward the center.

* Floor Construction: general slab → deck slab, Support Method: temporary support (supporting post) → concrete fake wall

** Design condition (10.84 kN/m²) → Site condition (24.49 kN/m², +13.65 kN/m², 2.26 times the weight of original plan)

② The first collapse was triggered by an early removal* of the bottom temporary supporting post of the PIT layer, causing the bottom slab of the PIT layer to support the load by itself, followed by continuous collapse toward the lower direction of the building.

* Standard specification for construction work states, “For a high-rise building under construction, the supporting post must be installed on at least three floors

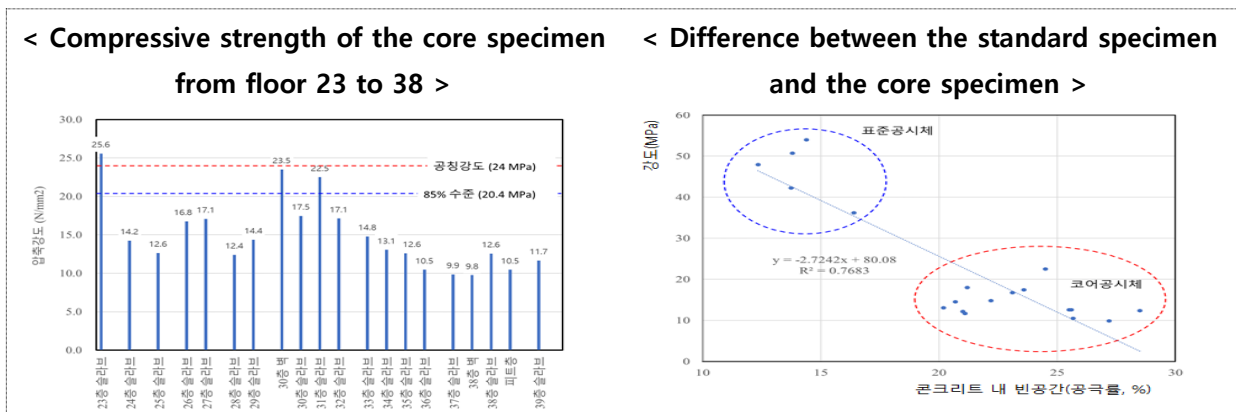
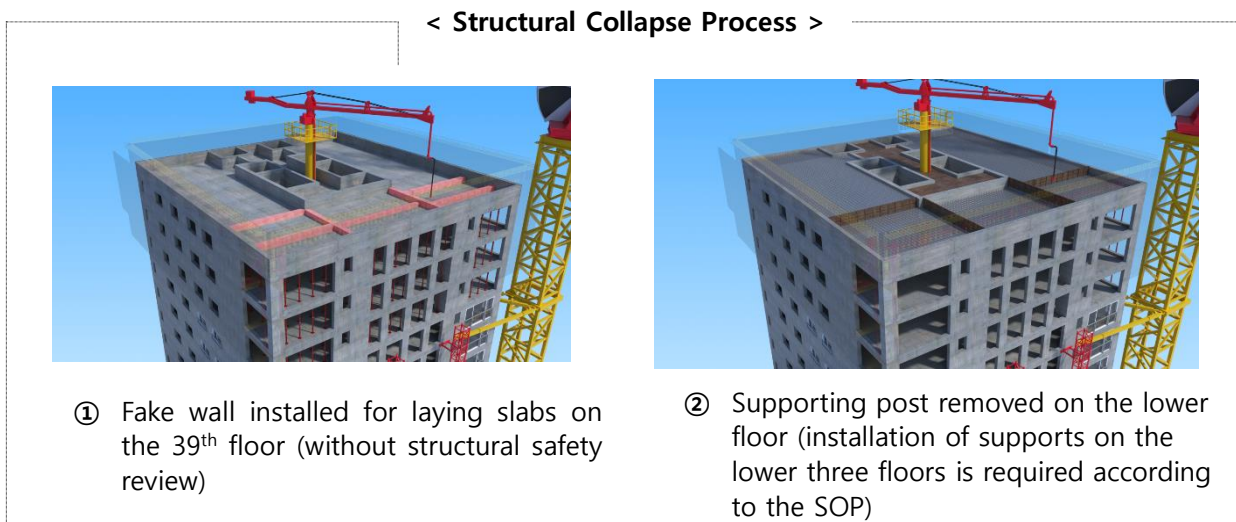
③ A strength test on the concrete specimens collected from the collapsed building showed that most specimens showed 85% level of strength compared to the designed standard strength. The lack of strength of the concrete triggered a decrease in the attachment rate to the rebar reinforcement, leading to a decrease in the safety rate of the building against any collapse.

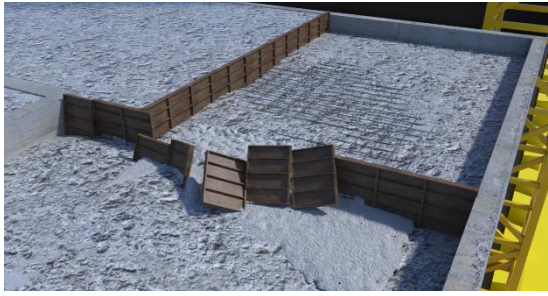
- ③ Occurrence of a shifting phenomenon toward the center while depositing concrete at the bottom with fixed load increasing

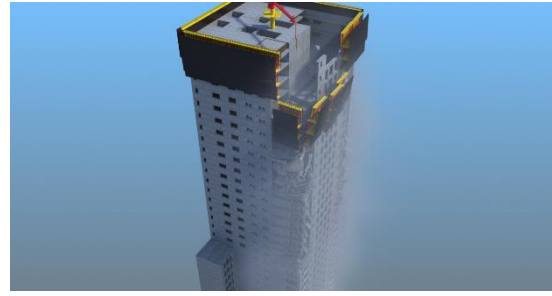
- ④ Occurrence of the collapse from the top floor to the 23rd floor (above the evacuation safety floor) as impact was applied to the lower part after the initial collapse of the PIT layer
